HOME REPORT

8 CASTLE STREET
THURSO
KW14 7JB

Energy Performance Certificate (EPC)

8 CASTLE STREET, THURSO, KW14 7JB

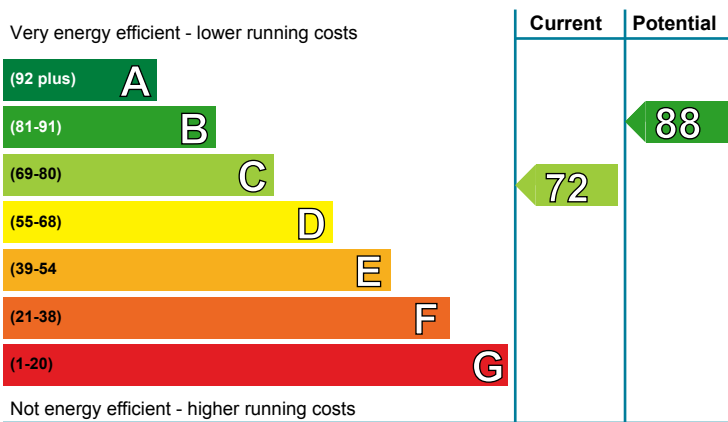
Energy Efficiency Rating

This graph shows the current efficiency of your home, taking into account both energy efficiency and fuel costs. The higher this rating, the lower your fuel bills are likely to be.

Your current rating is **band C (72)**. The average rating for EPCs in Scotland is **band D (61)**.

The potential rating shows the effect of undertaking all of the improvement measures listed within your recommendations report.
