## Single Survey Report

**Flotterston  
Sandwick  
KW16 3LP**

N J Coward, MRICS  
The Office  
Burgar House  
Evie  
KW17 2NJ

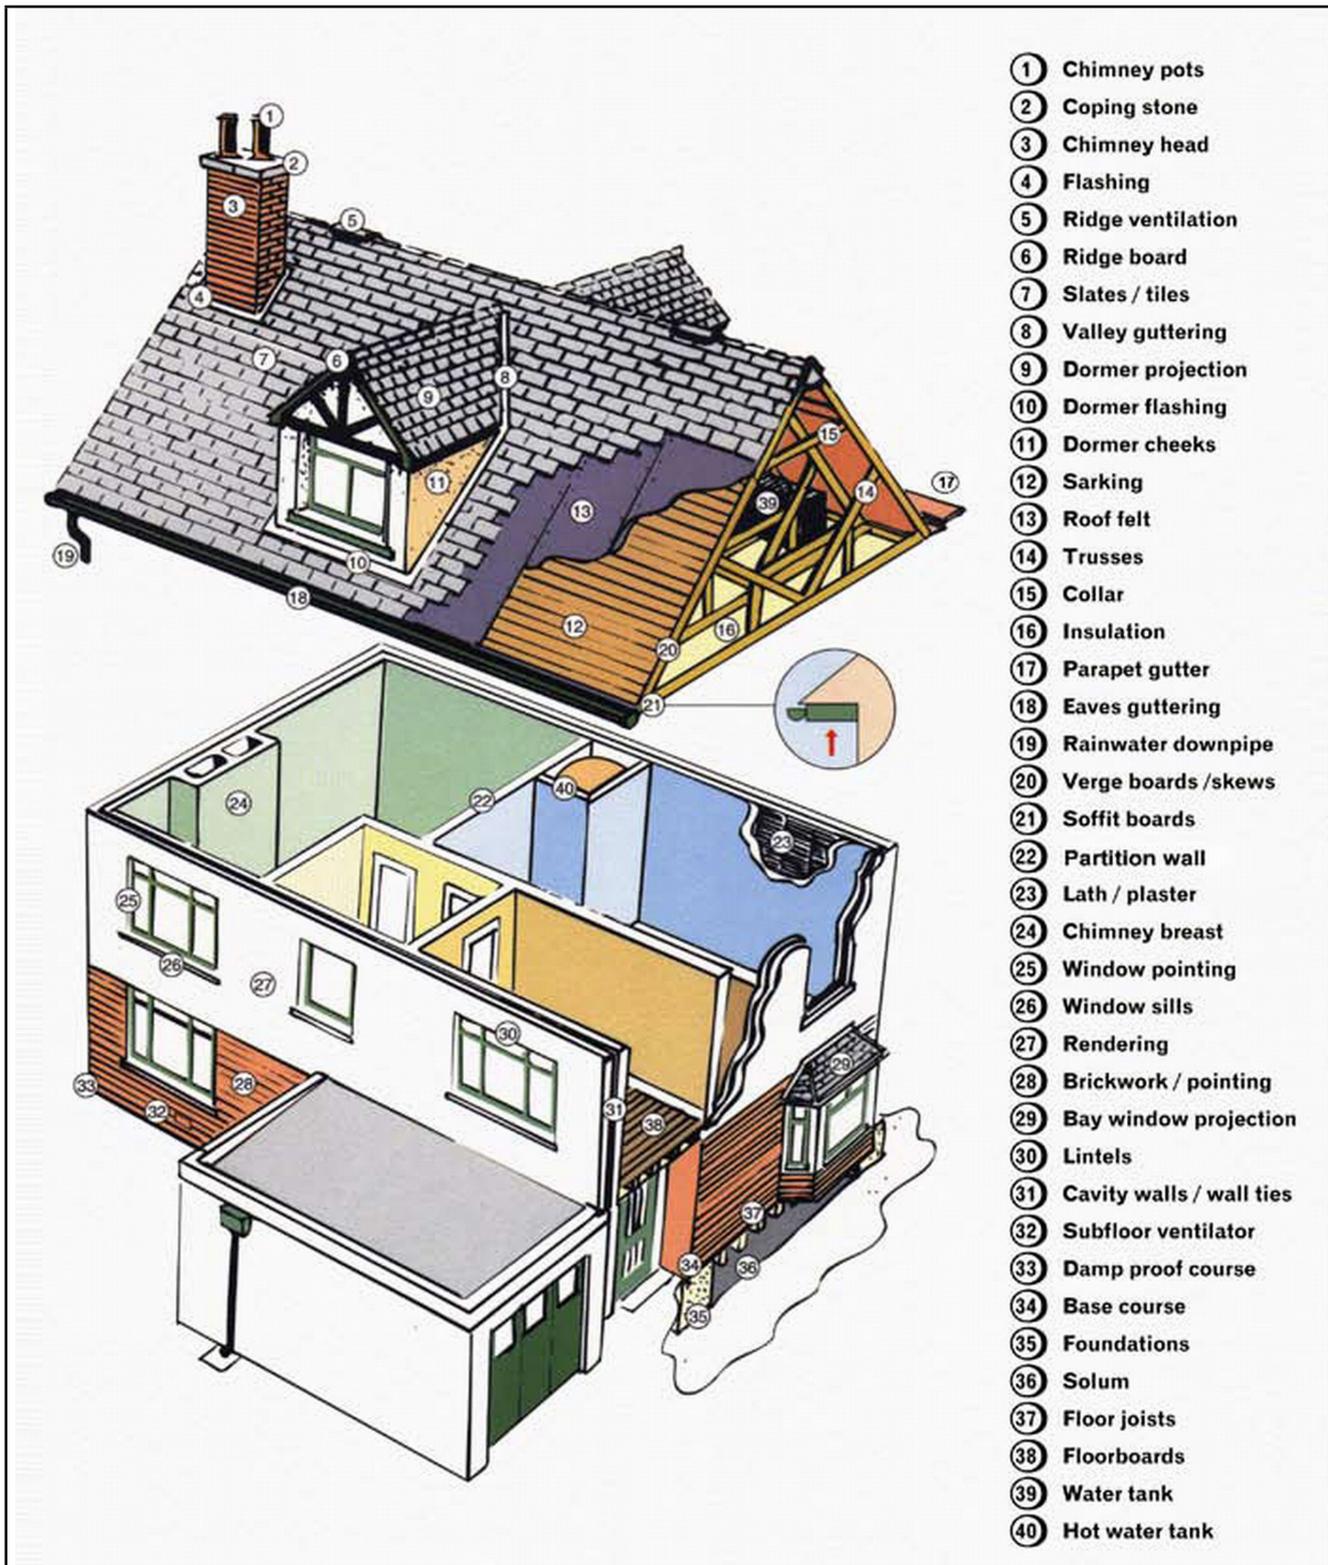
## Sectional diagram showing elements of a typical house

Reference may be made in this report to some or all of the above component parts of the property. This diagram may assist you in locating and understanding these terms.
