# Home Report

**Property address:** Mucklehouse  
Sandwick  
South Ronaldsay  
Orkney  
KW17 2RJ

**Date of inspection:** 24<sup>th</sup> June 2022

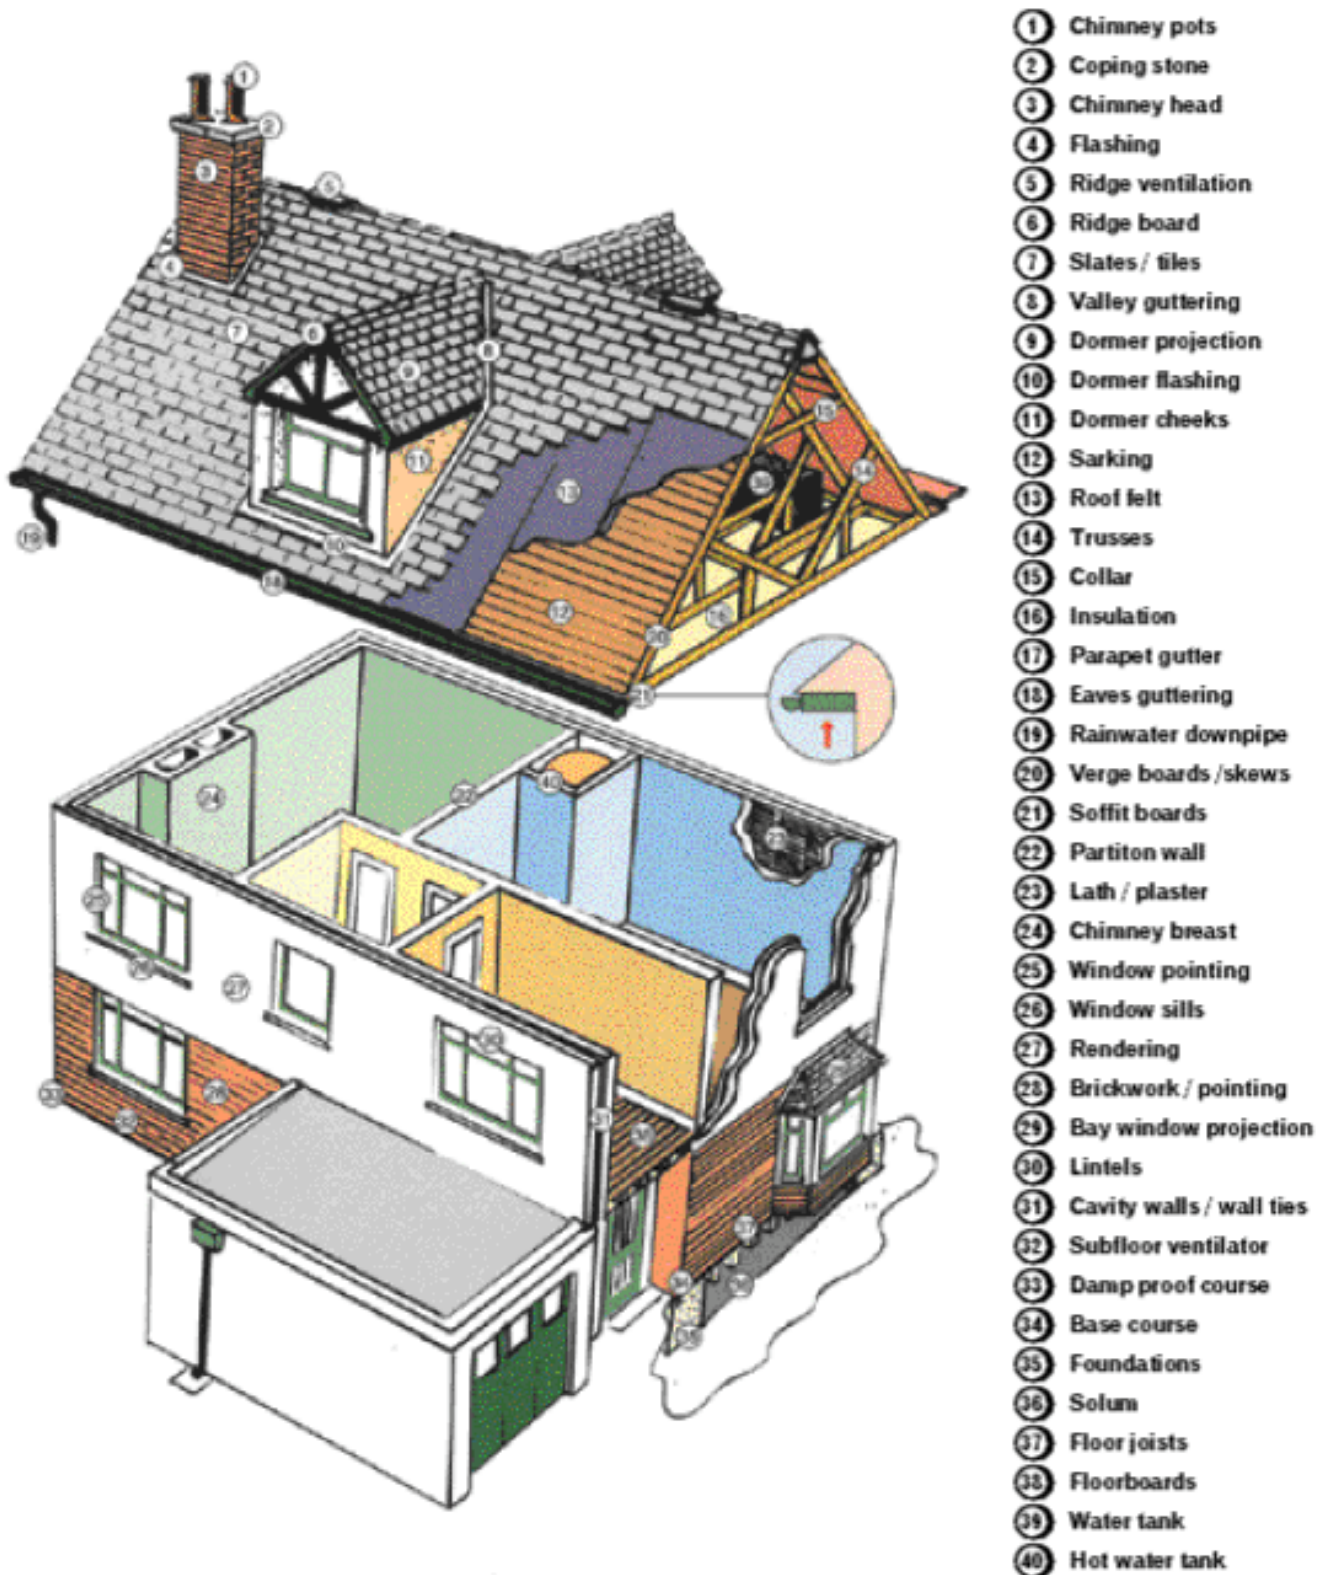
## Sectional diagram showing elements of a typical house

Reference may be made in this report to some or all of the above component parts of the property. This diagram may assist you in locating and understanding these terms.
