Home Report

Calvyden **Finstown** Orkney **KW17 2EL**

Property address: Calvyden

Date of inspection: 5th November 2024

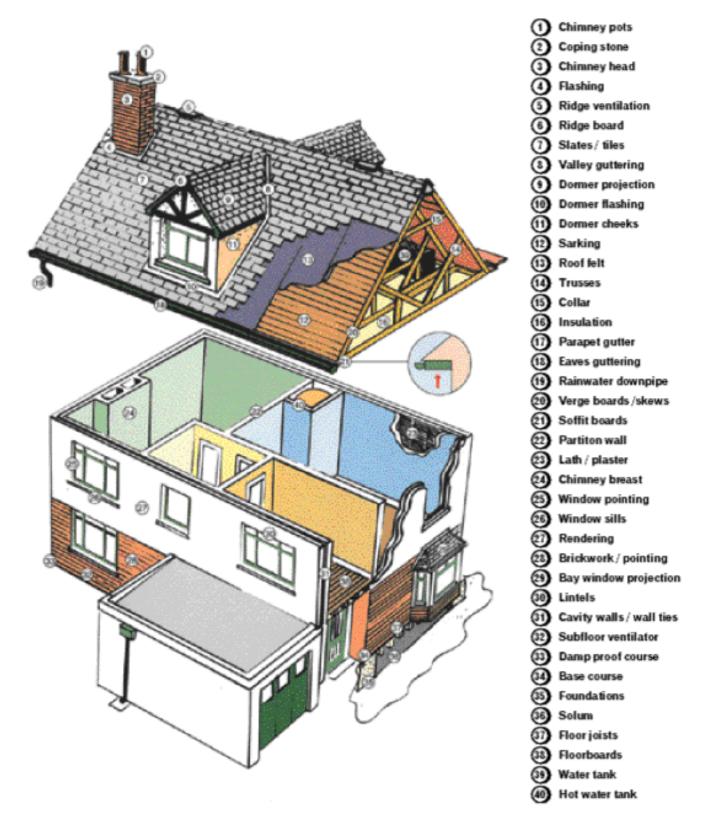
Sectional diagram showing elements of a typical house

Reference may be made in this report to some or all of the above component parts of the property. This diagram may assist you in locating and understanding these terms.
