Survey Report On

**Tower,
Gorseness Road,
Rendall,
Orkney,
KW17 2EX.**

Date of inspection: 7th January 2025.

Prepared by: Christopher J Omand, BSc (Hons), M.R.I.C.S.,
Chartered Valuation Surveyor,
R.I.C.S. Registered Valuer.

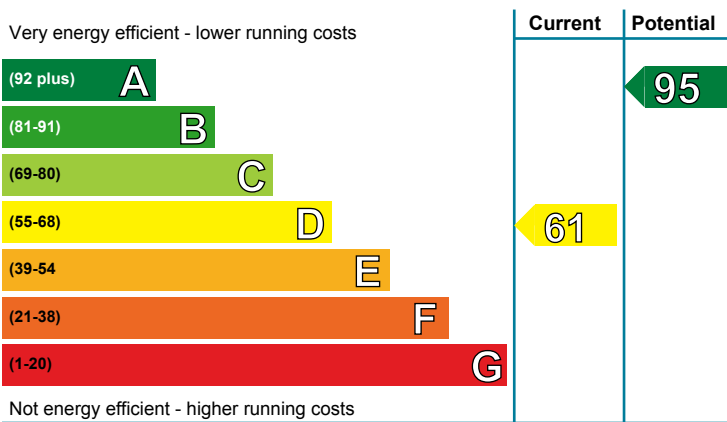
Energy Efficiency Rating

This graph shows the current efficiency of your home, taking into account both energy efficiency and fuel costs. The higher this rating, the lower your fuel bills are likely to be.

Your current rating is **band D (61)**. The average rating for EPCs in Scotland is **band D (61)**.

The potential rating shows the effect of undertaking all of the improvement measures listed within your recommendations report.

Estimated energy costs for your home for 3 years*	£10,692	See your recommendations report for more information
Over 3 years you could save*	£3,807

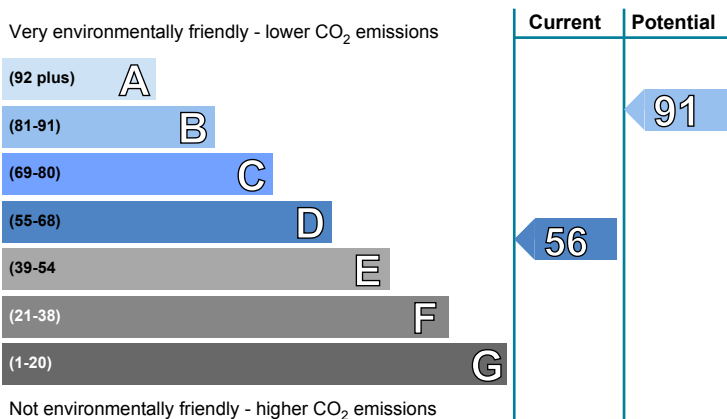
Environmental Impact (CO₂) Rating

This graph shows the effect of your home on the environment in terms of carbon dioxide (CO₂) emissions. The higher the rating, the less impact it has on the environment.
