# HOME REPORT

LORNEFIELD  
9 THURSO ROAD  
WICK  
KW1 5LE

# ENERGY PERFORMANCE CERTIFICATE

# SINGLE SURVEY

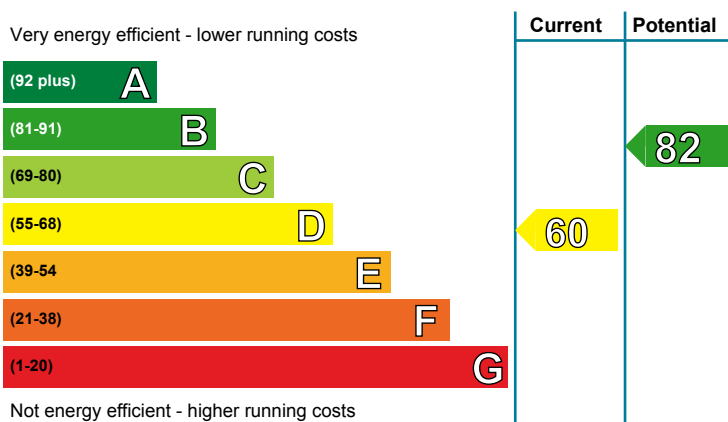
## Energy Efficiency Rating

This graph shows the current efficiency of your home, taking into account both energy efficiency and fuel costs. The higher this rating, the lower your fuel bills are likely to be.

Your current rating is **band D (60)**. The average rating for EPCs in Scotland is **band D (61)**.

The potential rating shows the effect of undertaking all of the improvement measures listed within your recommendations report.
