Single Survey Report

The Old Mill Burray

Date of inspection: 09/04/2025

Prepared by: N J Coward, MRICS

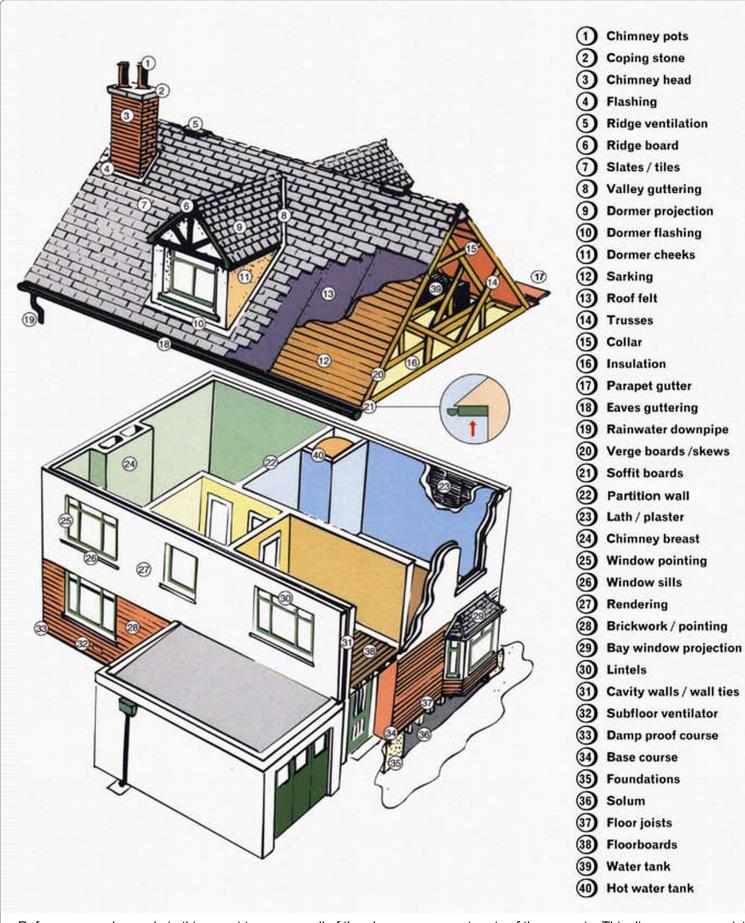
Sectional diagram showing elements of a typical house

Reference may be made in this report to some or all of the above component parts of the property. This diagram may assist you in locating and understanding these terms.
