## Single Survey Report

### **Flotterston House Sandwick**

06/08/2025

N J Coward, MRICS  
The Office  
Burgar House  
Evie  
KW17 2NJ

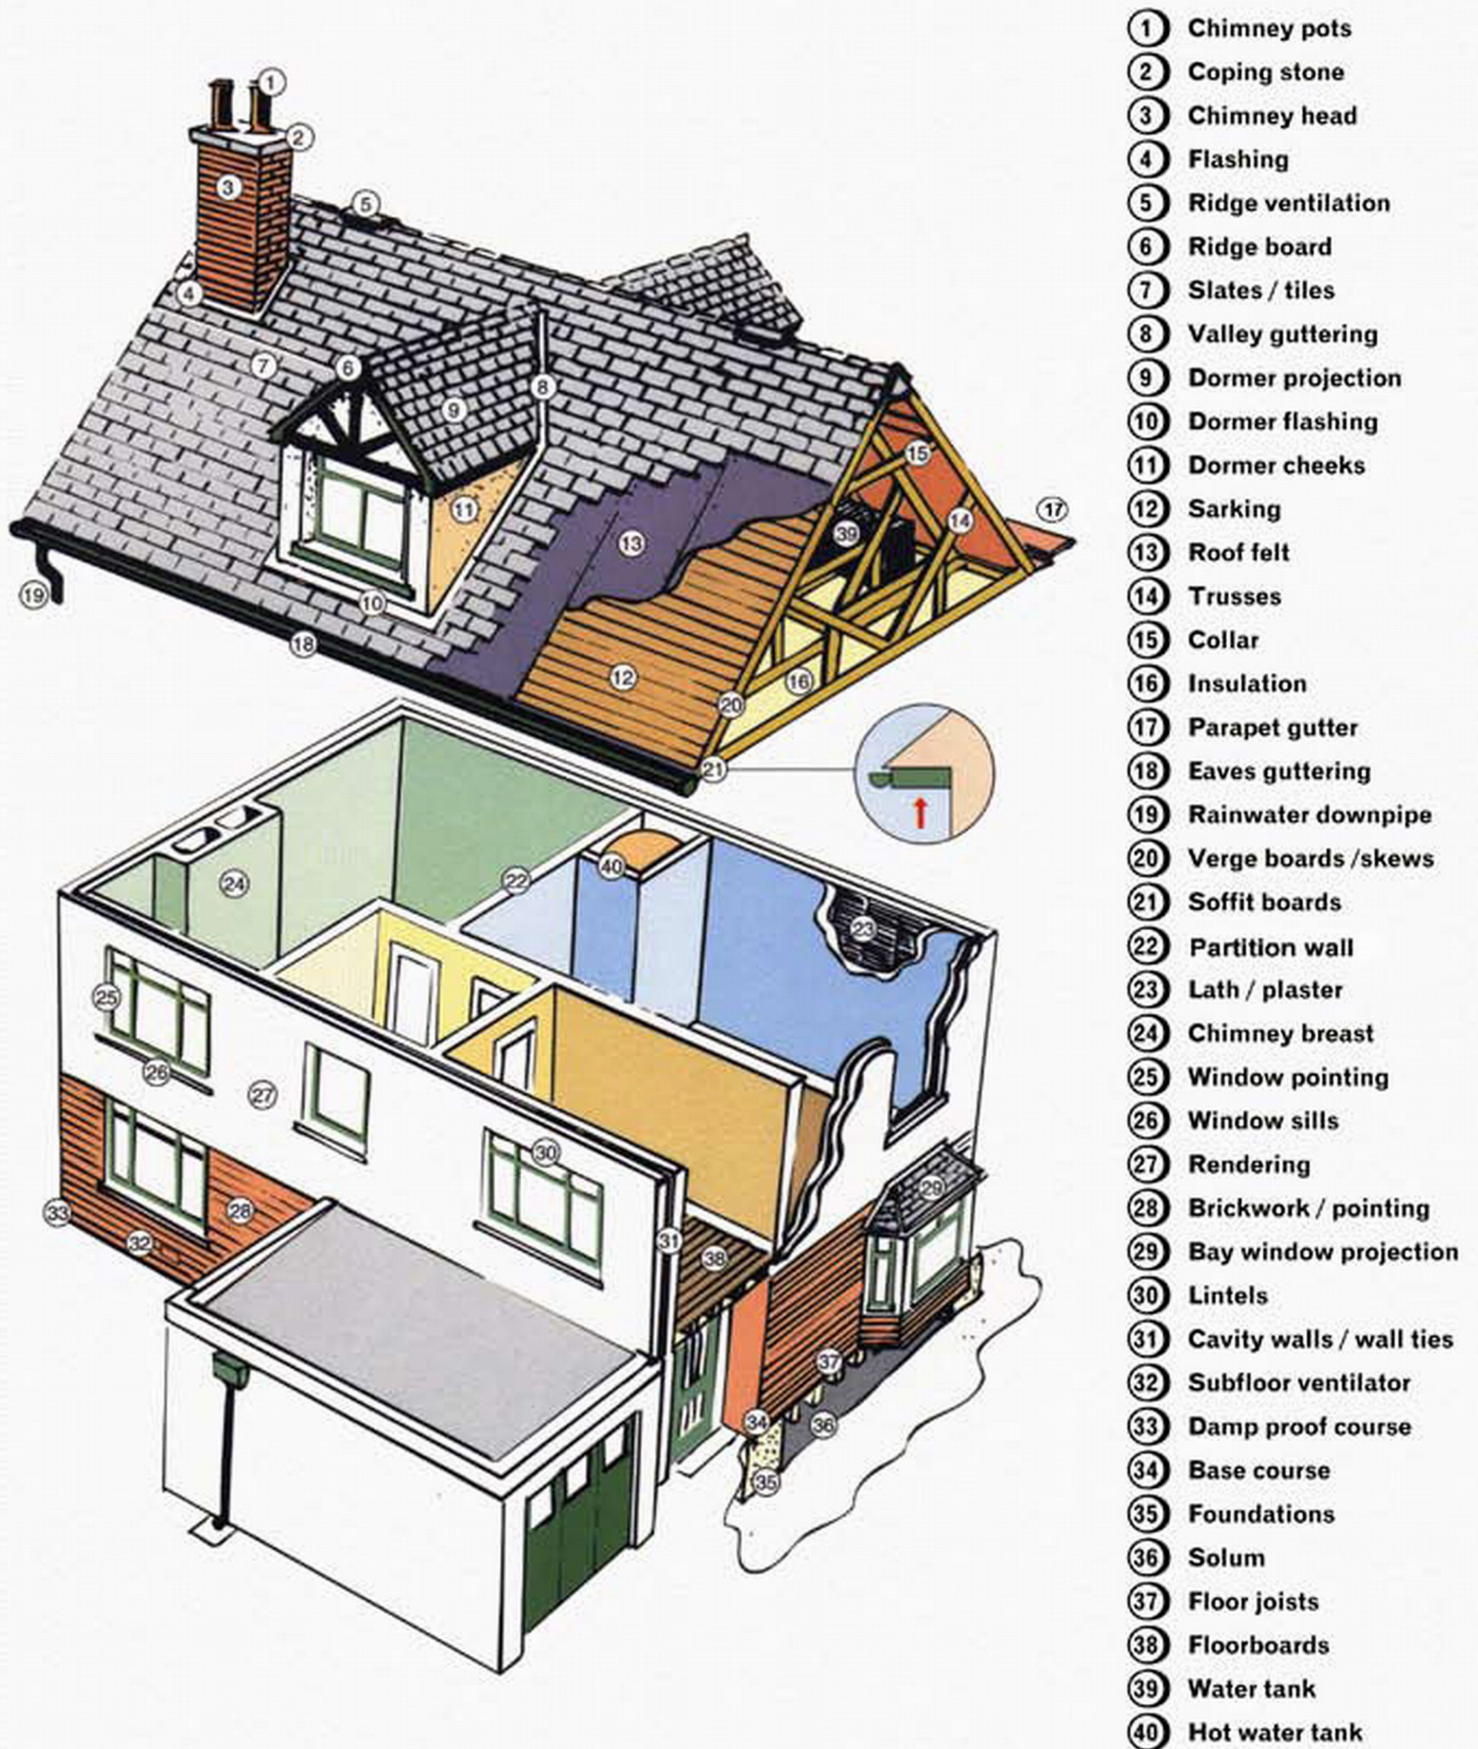
## Sectional diagram showing elements of a typical house

Reference may be made in this report to some or all of the above component parts of the property. This diagram may assist you in locating and understanding these terms.
