Single Survey Report

Aurrida View Finstown

09/08/2025

N J Coward, MRICS
The Office
Burgar House
Evie
KW17 2NJ

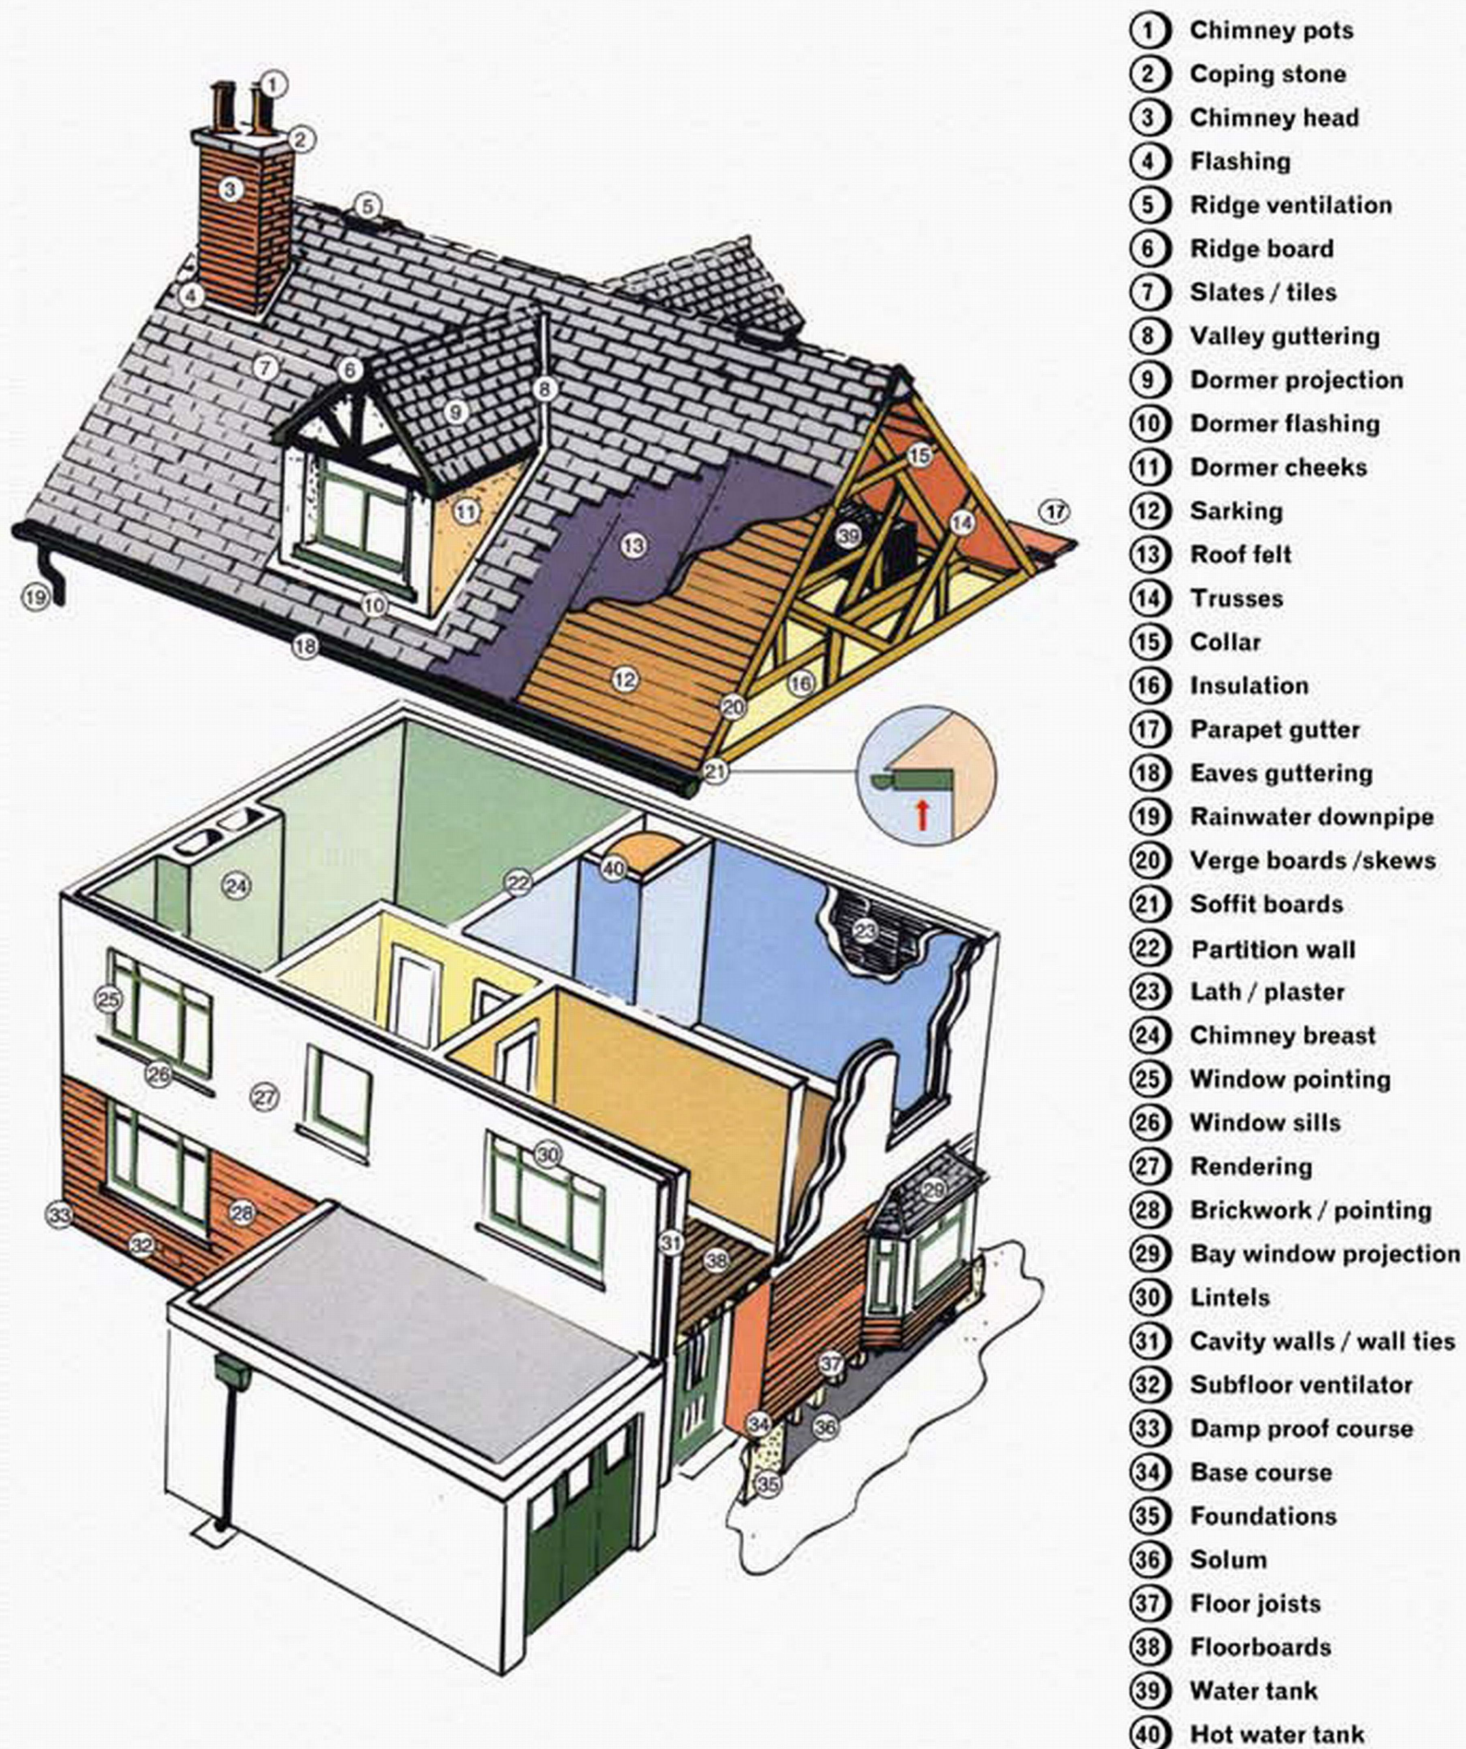
Sectional diagram showing elements of a typical house

Reference may be made in this report to some or all of the above component parts of the property. This diagram may assist you in locating and understanding these terms.
