# Home Report

**Lochside  
Dounby  
Orkney  
KW17 2HP**

**Property address:** Lochside  
Dounby  
Orkney  
KW17 2HP

**Date of inspection:** 10<sup>th</sup> July 2025

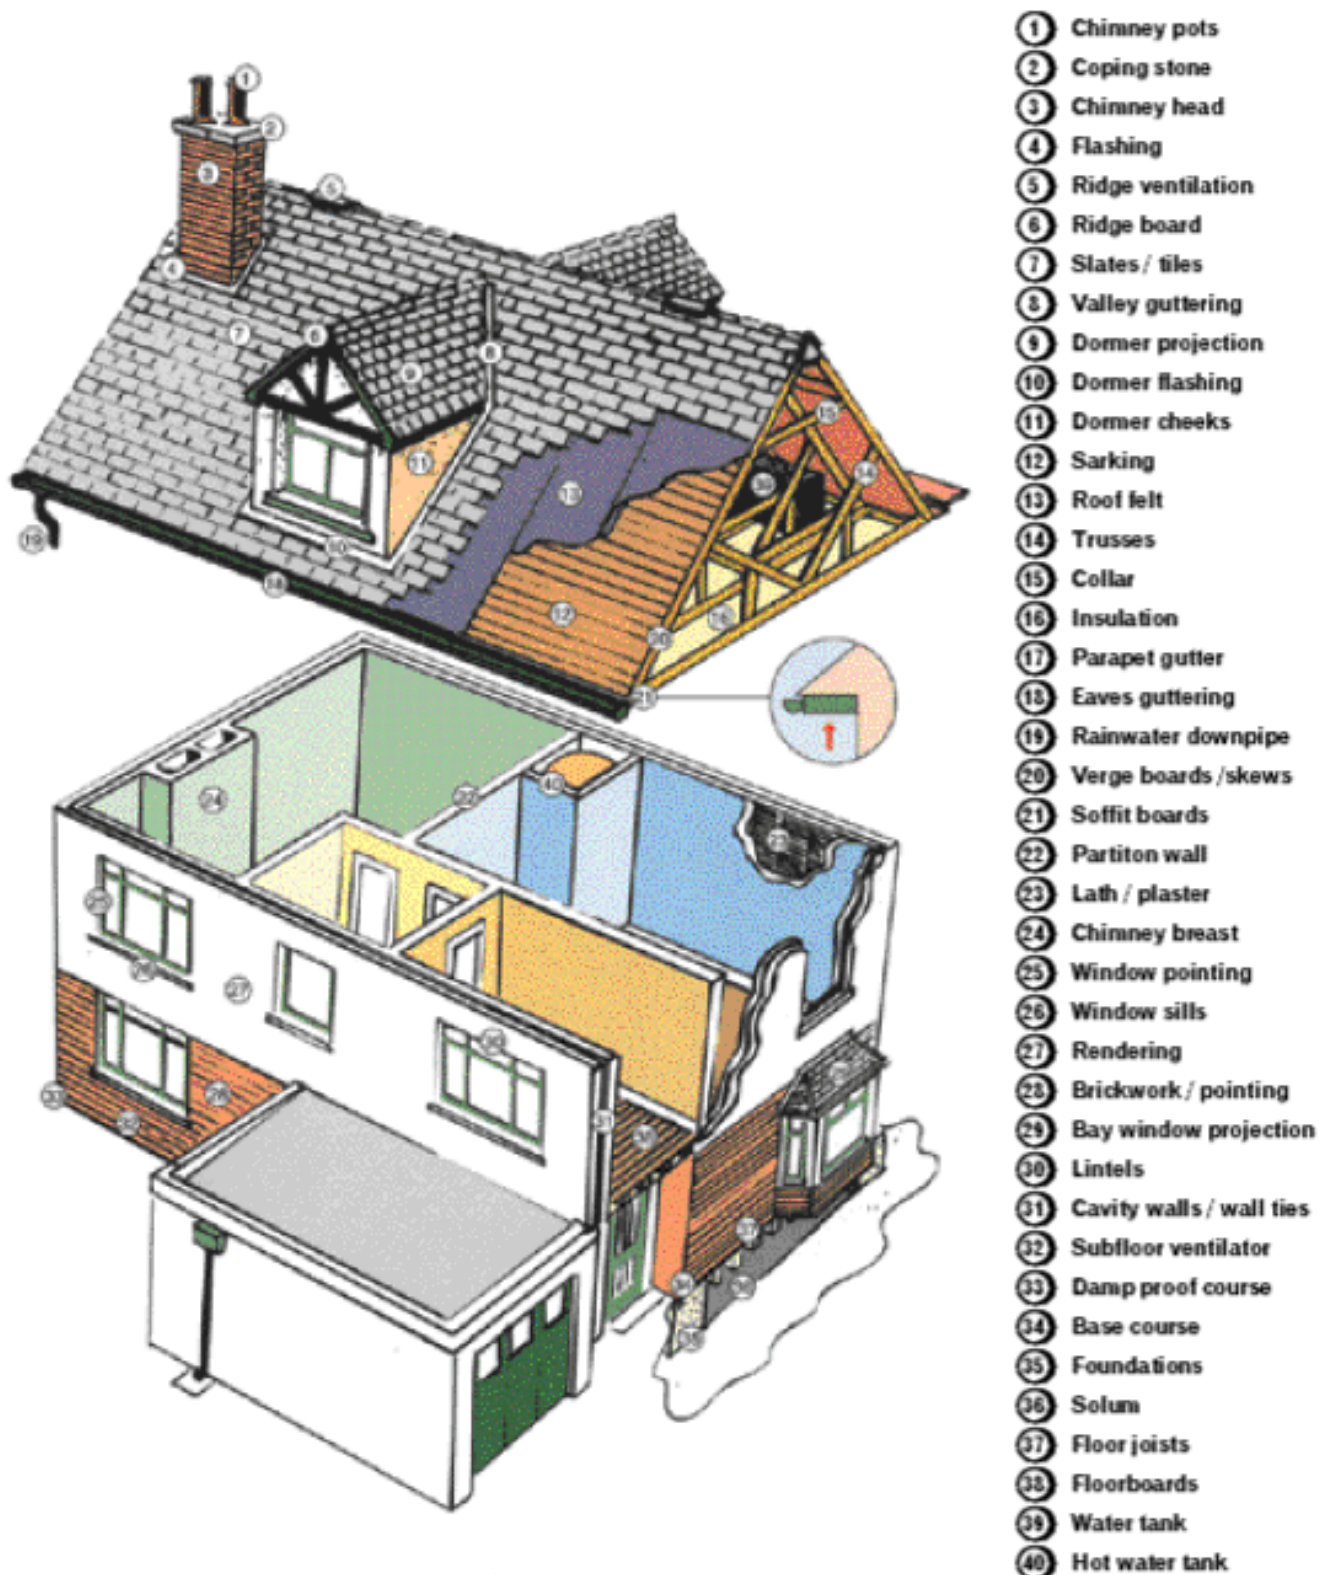
## Sectional diagram showing elements of a typical house

Reference may be made in this report to some or all of the above component parts of the property. This diagram may assist you in locating and understanding these terms.
