Bluebraes,
Finstown,
Orkney,
KW17 2PA

Home Report

Single Survey

Property Address	Bluebraes, Finstown, Orkney, KW17 2PA
Reference	1153089
Customer Name	XX
Date of Inspection	13th August 2025
Surveyor's name, qualifications and office	Lesley Coghill BSc (Hons) MRICS BSc (Hons) MRICS DM Hall LLP Chartered Surveyors Hope House, Cradlehall Business Park, Castlehill Drive Cradlehall Inverness IV2 5GH Tel: 01463 241077 email: invernessresidential@dmhall.co.uk
Prepared By	DM Hall LLP

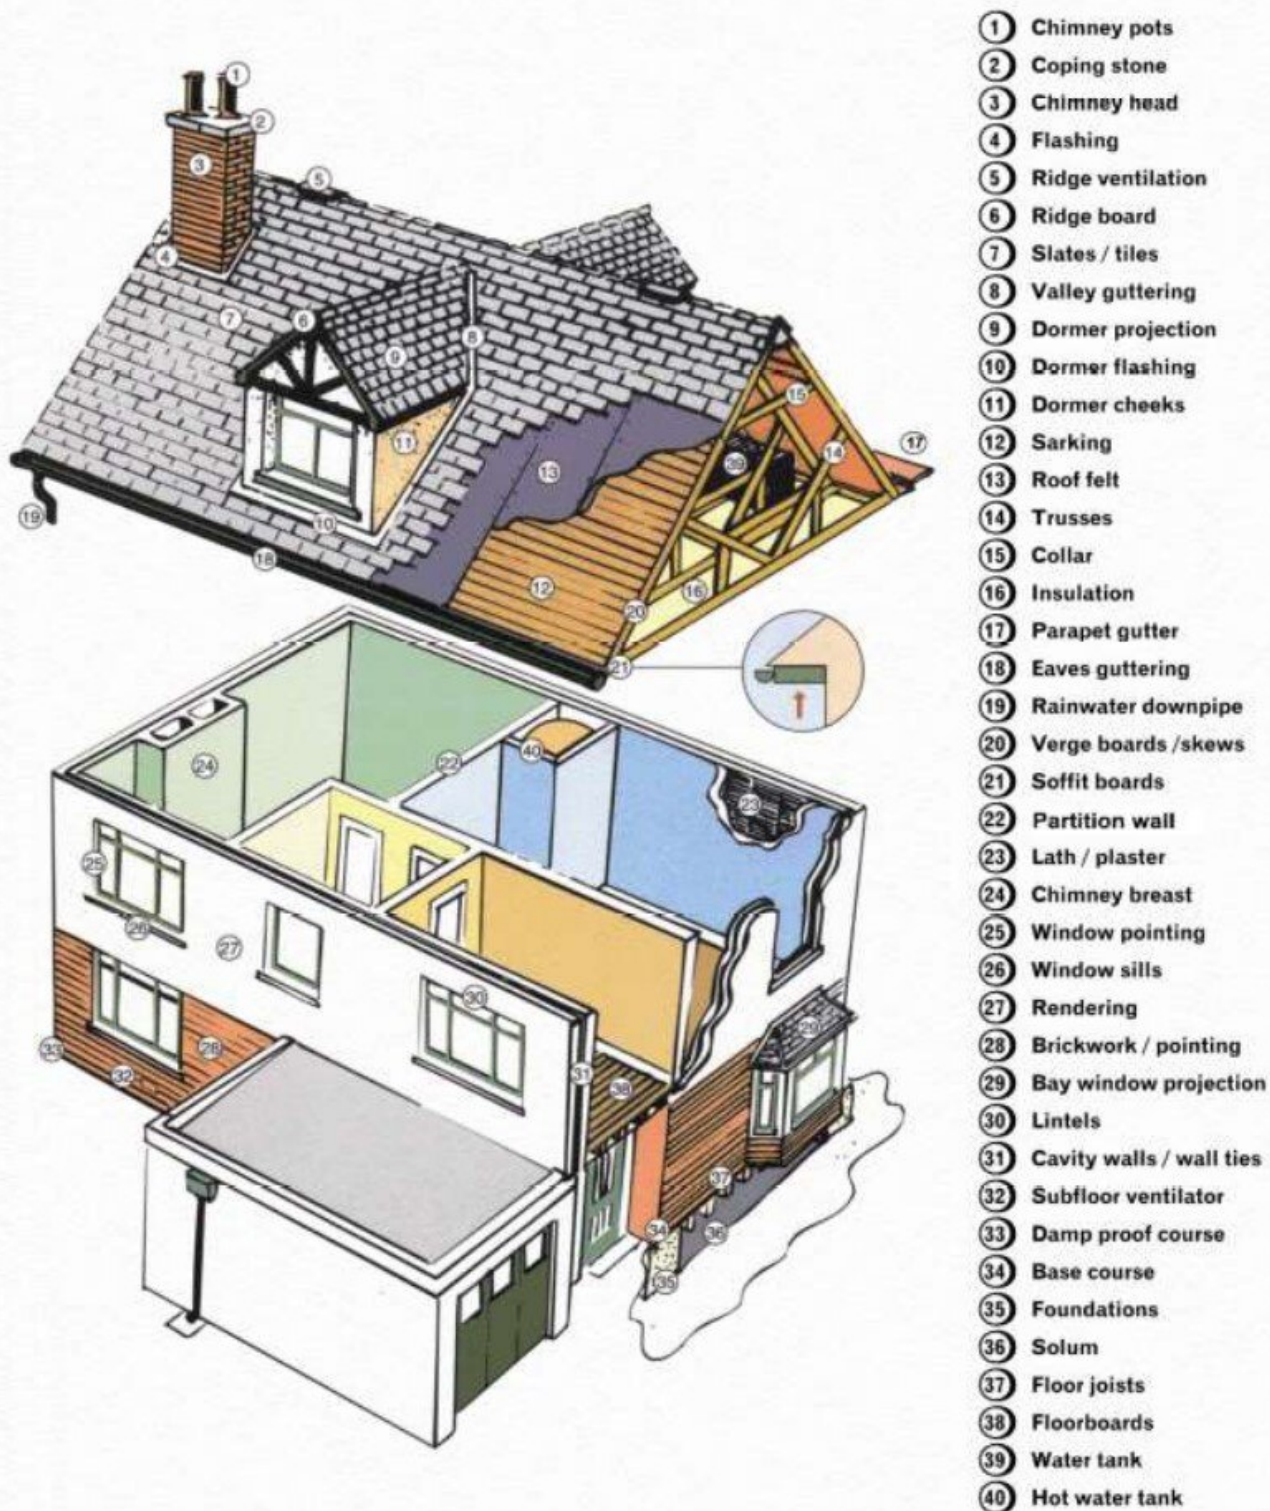
Sectional Diagram showing elements of a typical house

Reference may be made in this report to some or all of the above component parts of the property. This diagram may assist you in locating and understanding these items.

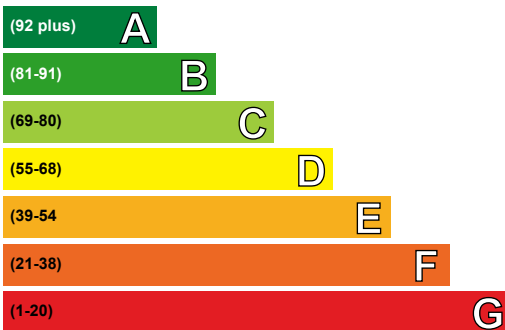
Energy Efficiency Rating

Very energy efficient - lower running costs

Current	Potential
	81
23

The potential rating shows the effect of undertaking all of the improvement measures listed within your recommendations report.

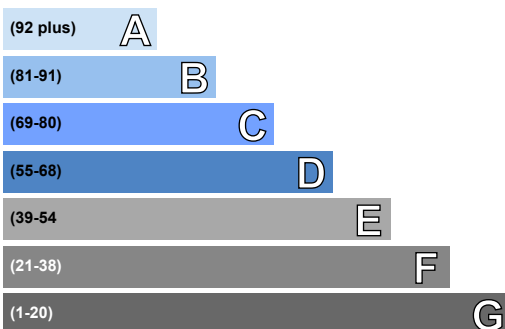
Environmental Impact (CO₂) Rating

Very environmentally friendly - lower CO₂ emissions

Current	Potential
	87
74
