## Survey Report On

Vesker,  
Twatt  
Birsay,  
Orkney,  
KW17 2LZ.

**Client:** ~~Mr Philip Carberry~~  
**Client address:** Vesker, Twatt, Birsay, Orkney, KW17 2LZ  
**Date of inspection:** 29<sup>th</sup> October 2025.  
**Prepared by:** Christopher J Omand, BSc (Hons), M.R.I.C.S.,  
Chartered Valuation Surveyor,  
R.I.C.S. Registered Valuer.

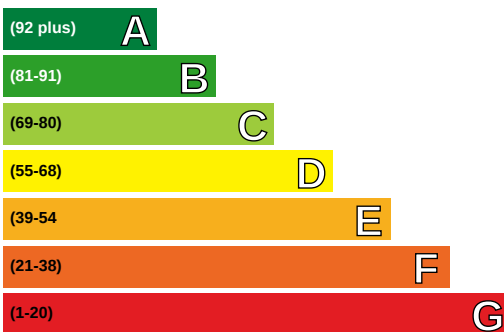
\* based upon the cost of energy for heating, hot water, lighting and ventilation, calculated using standard assumptions

Very energy efficient - lower running costs

Not energy efficient - higher running costs

The potential rating shows the effect of undertaking all of the improvement measures listed within your recommendations report.

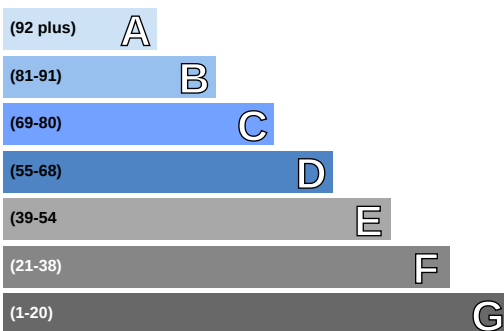
Very environmentally friendly - lower CO<sub>2</sub> emissions

Not environmentally friendly - higher CO<sub>2</sub> emissions
