Survey Report On

**Bayview,
Rue Road,
Sanday,
Orkney,
KW17 2AZ.**

Prepared by: **Christopher J Omand, BSc (Hons), M.R.I.C.S.,
Chartered Valuation Surveyor,
R.I.C.S. Registered Valuer.**

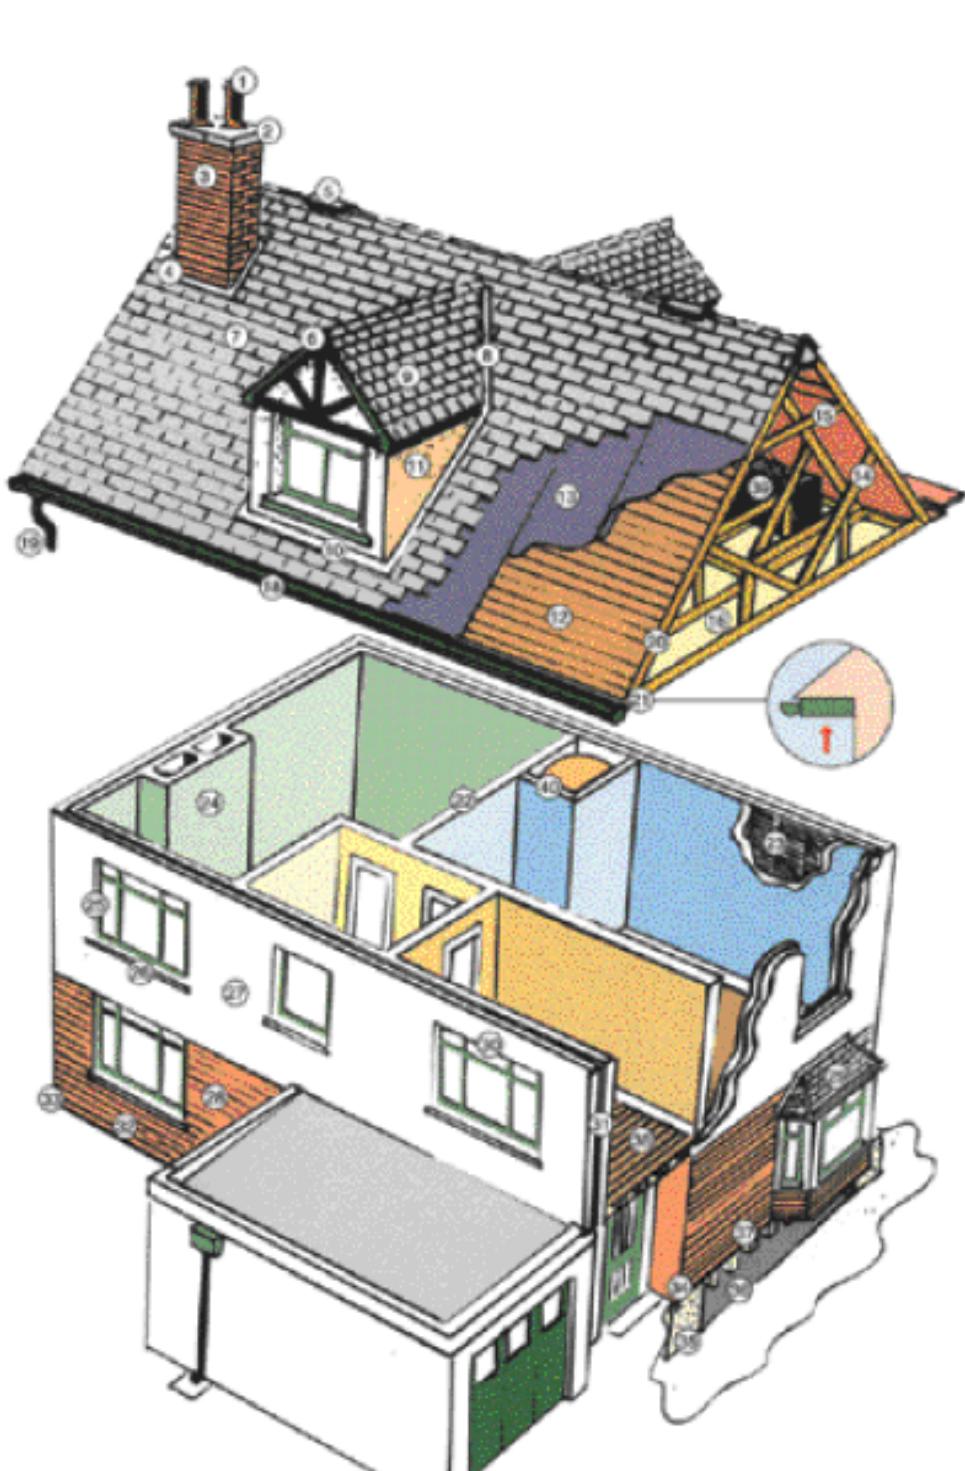
Sectional diagram showing elements of a typical house

- 1. Chimney pots
- 2. Coping stone
- 3. Chimney head
- 4. Flashing
- 5. Ridge ventilation
- 6. Ridge board
- 7. Slates / tiles
- 8. Valley guttering
- 9. Dormer projection
- 10. Dormer flashing
- 11. Dormer cheeks
- 12. Sarking
- 13. Roof felt
- 14. Trusses
- 15. Collar
- 16. Insulation
- 17. Parapet gutter
- 18. Eaves guttering
- 19. Rainwater downpipe
- 20. Verge boards / skews
- 21. Soffit boards
- 22. Partition wall
- 23. Lath / plaster
- 24. Chimney breast
- 25. Window pointing
- 26. Window sills
- 27. Rendering
- 28. Brickwork / pointing
- 29. Bay window projection
- 30. Lintels
- 31. Cavity walls / wall ties
- 32. Subfloor ventilator
- 33. Damp proof course
- 34. Base course
- 35. Foundations
- 36. Solum
- 37. Floor joists
- 38. Floorboards
- 39. Water tank
- 40. Hot water tank

Reference may be made in this report to some or all of the above component parts of the property. This diagram may assist you in locating and understanding these terms.
