Survey Report On

**Standing Stone,
Littlequoy Road,
Burray,
Orkney,
KW17 2SX.**

Prepared by: Christopher J Omand, BSc (Hons), M.R.I.C.S.,
Chartered Valuation Surveyor,
R.I.C.S. Registered Valuer.

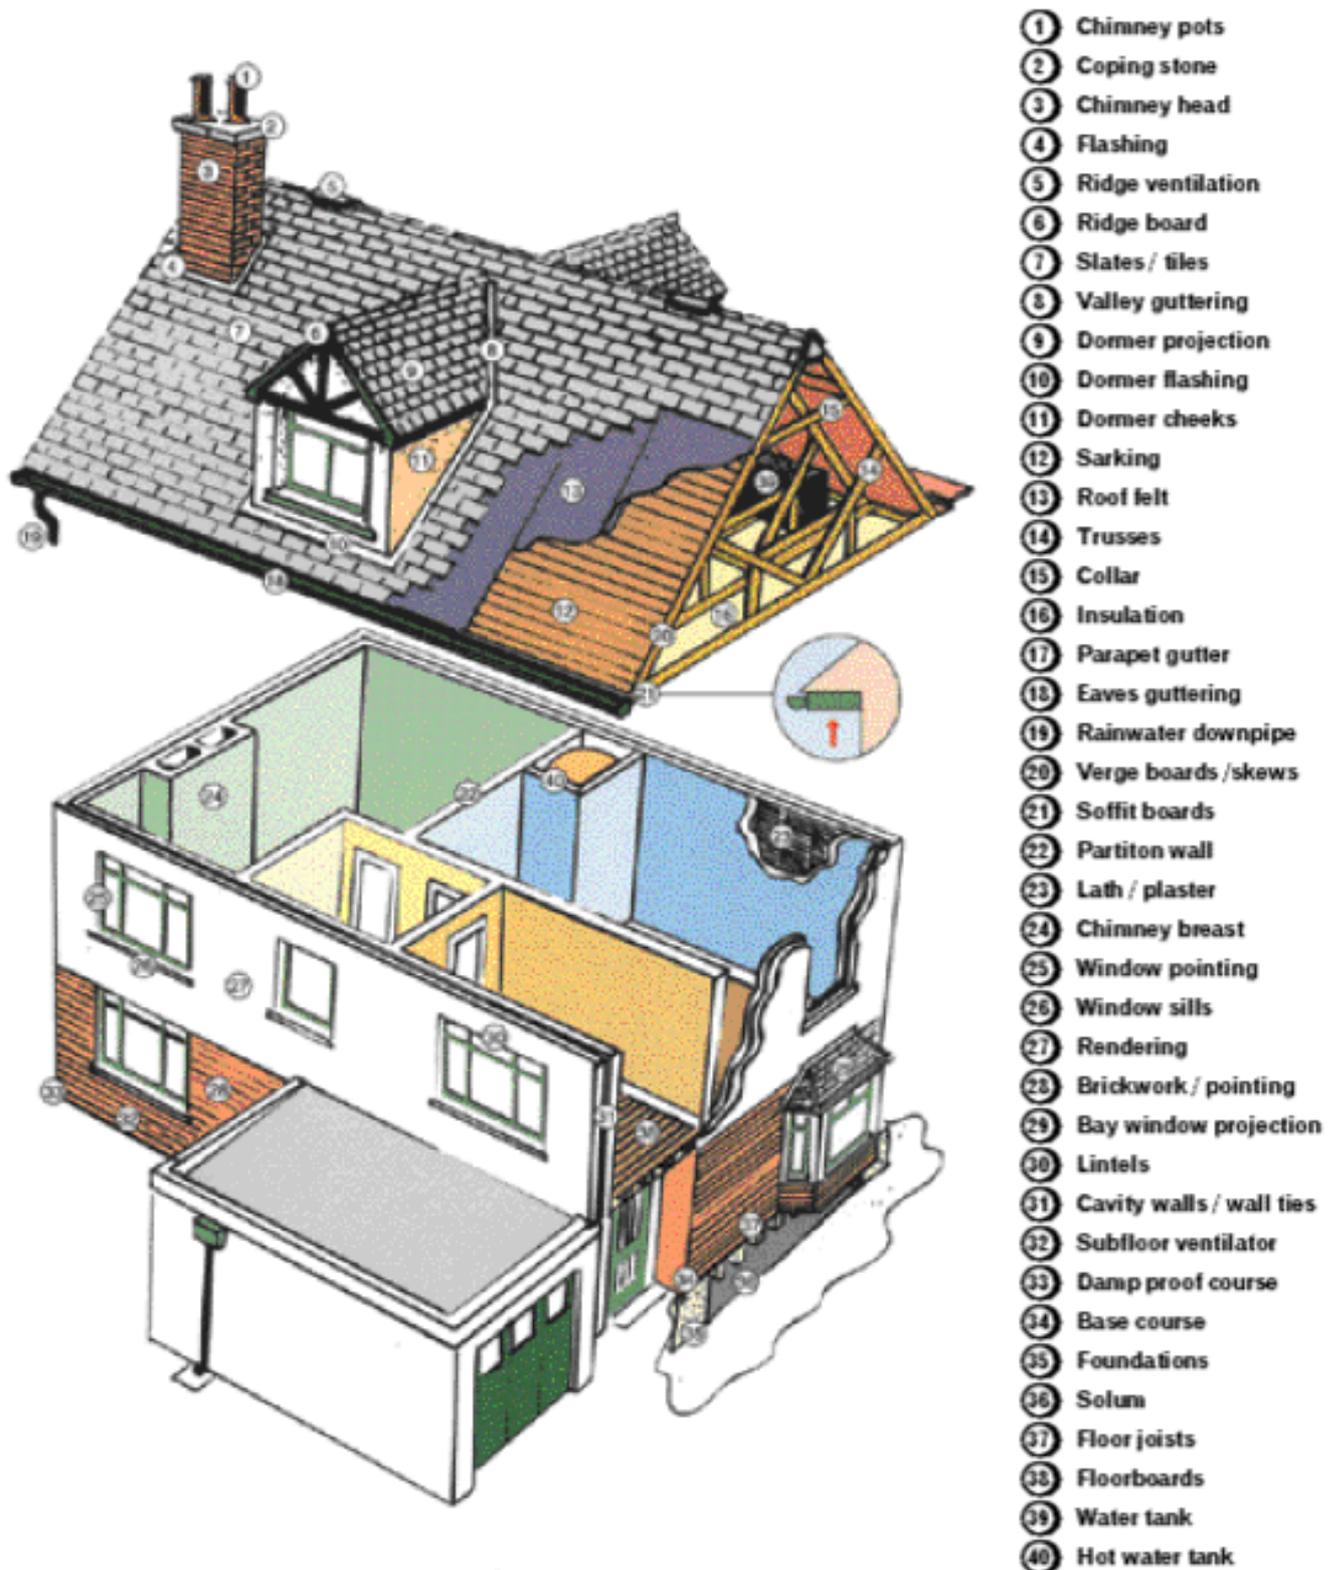
Sectional diagram showing elements of a typical house

Reference may be made in this report to some or all of the above component parts of the property. This diagram may assist you in locating and understanding these terms.

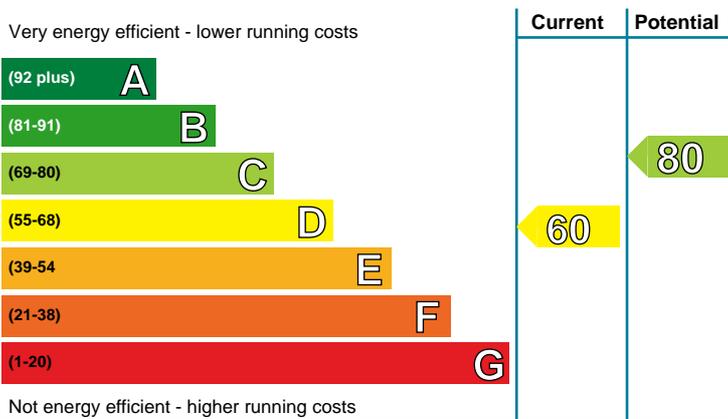
Energy Efficiency Rating

This graph shows the current efficiency of your home, taking into account both energy efficiency and fuel costs. The higher this rating, the lower your fuel bills are likely to be.

Your current rating is **band D (60)**. The average rating for EPCs in Scotland is **band D (61)**.

The potential rating shows the effect of undertaking all of the improvement measures listed within your recommendations report.

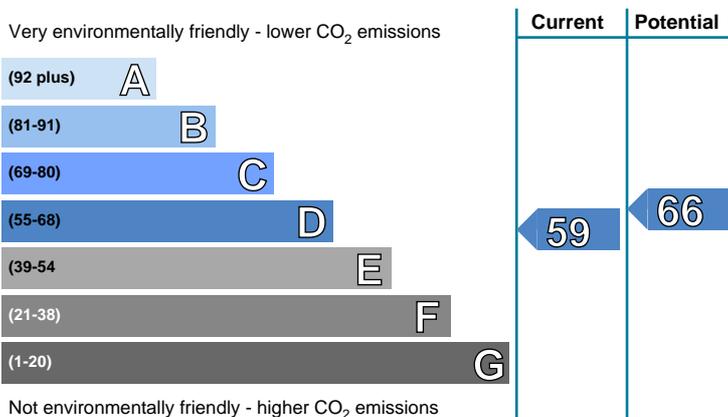
Environmental Impact (CO₂) Rating

This graph shows the effect of your home on the environment in terms of carbon dioxide (CO₂) emissions. The higher the rating, the less impact it has on the environment.
