Home Report

**South House
Eday
Orkney
KW17 2AB**

Property address: South House
Eday
Orkney
KW17 2AB

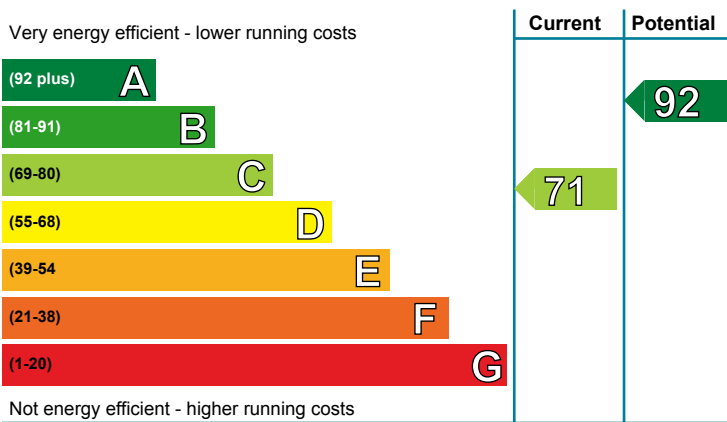
Energy Efficiency Rating

This graph shows the current efficiency of your home, taking into account both energy efficiency and fuel costs. The higher this rating, the lower your fuel bills are likely to be.

Your current rating is **band C (71)**. The average rating for EPCs in Scotland is **band D (61)**.

The potential rating shows the effect of undertaking all of the improvement measures listed within your recommendations report.

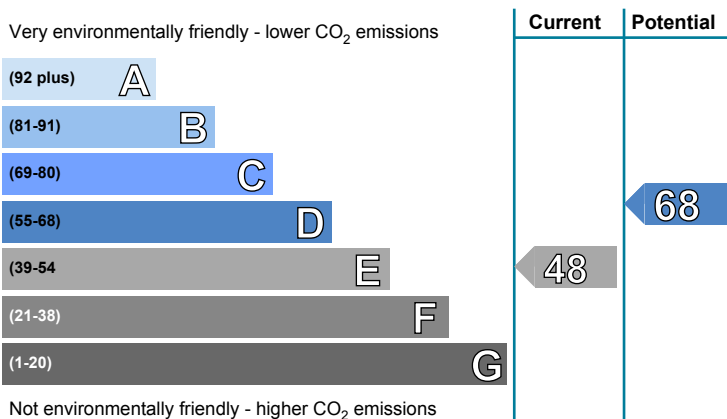
Environmental Impact (CO₂) Rating

This graph shows the effect of your home on the environment in terms of carbon dioxide (CO₂) emissions. The higher the rating, the less impact it has on the environment.
